## Preventing water ingress to 25kV Track Sectioning Cabin

Ref: NRA21-05

Location: Carstairs TSC, Scotland Region

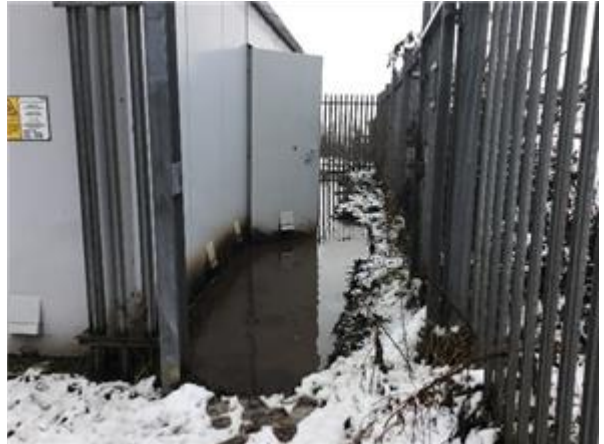
In a recent incident in Scotland Region, significant flooding was discovered in and around a 25kV Track Sectioning Cabin (TSC) at Carstairs. Pools of water inside and outside the cabin are also believed to extend underneath the building's false floor creating damp conditions and potential corrosion of the traction power equipment within. The site dehumidifier was out of service and several defective heaters were found.

Investigation found the site was particularly vulnerable to flooding from an adjacent haulier's yard on higher ground. A previous flashover of traction power equipment is now thought to be due to unusually high levels of moisture in and around the building.

Heating and dehumidification equipment have been rectified to bring moisture levels within the building under control. Work is in progress to improve drainage at the site.

- Apply extra vigilance when accessing or inspecting lineside buildings, particularly those that contain electrical equipment.
- Assess the area around the site to identify factors that may increase the risk of flooding. For example, sites situated on low ground, vulnerable to run-off from adjacent premises or with poor drainage.
- Report any fabric damage, flooding or water ingress at a lineside building to the Operational Property Helpdesk [OPHD@networkrail.co.uk](mailto:OPHD@networkrail.co.uk)
- Report any concerns with the building environmental controls.
