Safety Advice

Train struck hand trolley

Ref: NRA21-14

Location: Twickenham Station, Wessex route

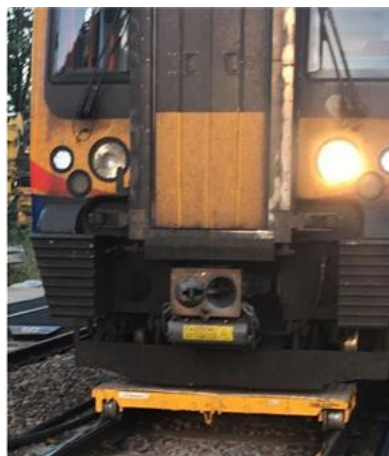
On Wednesday 8 September 2021, after a possession had been given up, a passenger train struck a hand trolley that had been left on the Up Main line near Twickenham Station.

On collision, the trolley became wedged under the front carriage of the train.

- All COSSs, Safe Work Leaders (SWL) and Engineering Supervisors (ES) must comply with their duties relating to line clear verification (LCV), including complete worksite sweeps, to make sure the line is safe for the passage of trains before handing their worksite back.
- All vehicles, including hand trolleys, placed on the line must be recorded (by the Machine Controller / COSS / SWL / ES / PICOP) on the appropriate LCV forms and cross referenced when each vehicle is removed from the line.
